PERDIDO DAM

REYNOLDS COUNTY, MISSOURI

MO 31042

**PHASE I INSPECTION REPORT
NATIONAL DAM SAFETY PROGRAM**

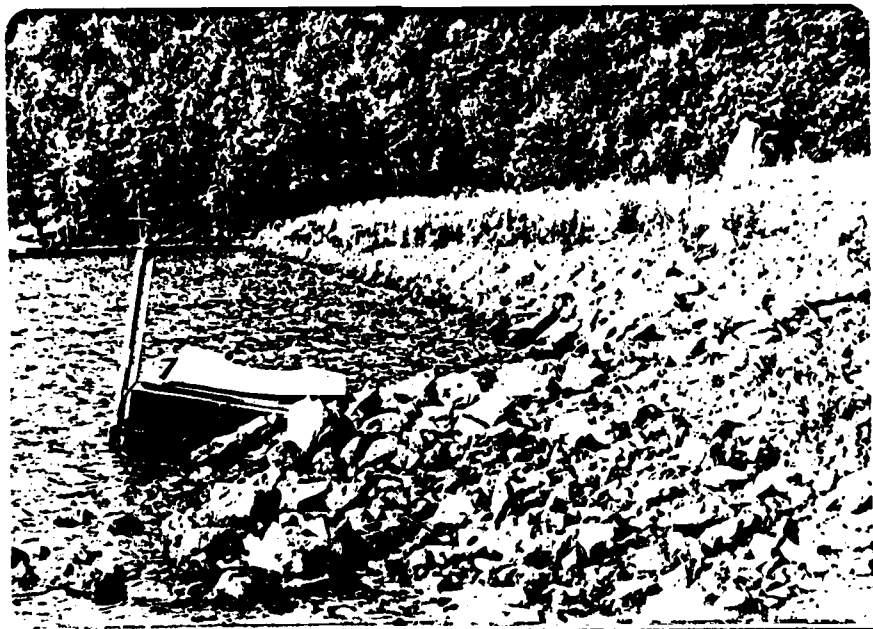
The drop inlet structure has been tilted approximately 5° from its initially constructed position. The structure is still serviceable, as evidenced by the fact that there was no leakage into the pipe, even though the water level was 3 feet above the pipe.

Photo 2 - View along upstream slope of embankment taken from spillway approach channel. Note intake structure for service spillway.

The physical condition of Perdido Dam is in generally satisfactory. The major problems with the dam and appurtenant structures involve the spillways. The service spillway structure should be repaired by resetting the con-

crete box inlet in a vertical position, and grouting around the structure to prevent future damage. A trashrack with bars should replace the existing wire mesh cover. The emergency spillway's left bank is in an unstable condition following recent discharges due to flooding. The spillway channel is sloped toward the left bank, causing flow through the spillway to concentrate in this area. It is predicted that future discharges through the spillway channel would rapidly breach the left bank, causing water to flow across the abutment and onto the downstream embankment.

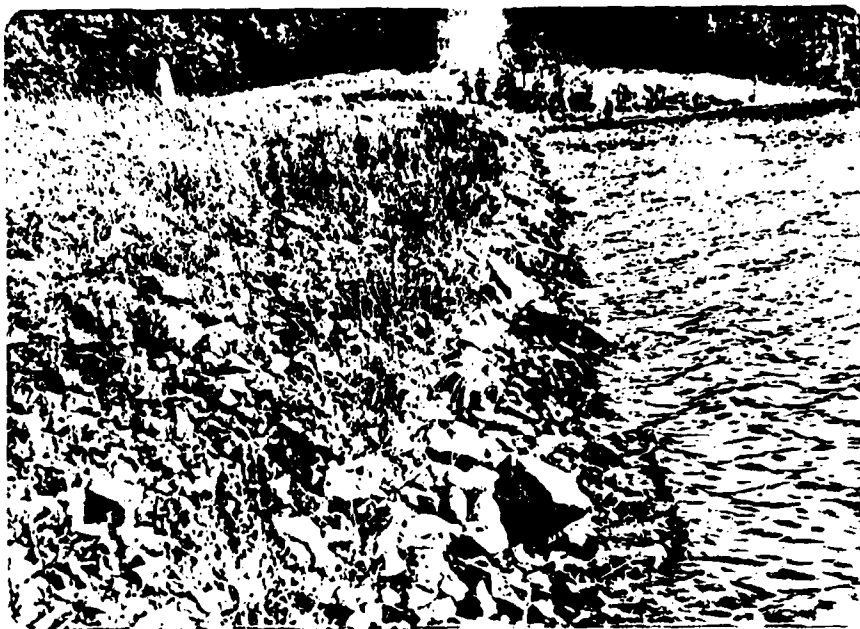
The riprap on the upstream embankment slope is providing excellent protection for the embankment material. No degradation due to weathering of the blocks was observed. Some minor surface erosion is occurring on the downstream

Photo 3 - Close-up of typical section of upstream slope of embankment.

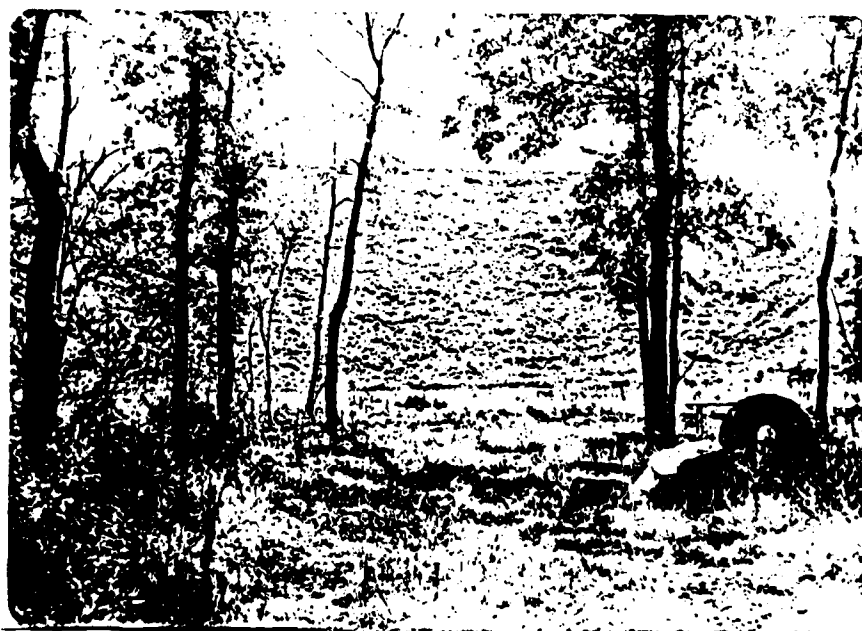
Photo 4 - View of downstream slope of embankment taken from downstream of dam.

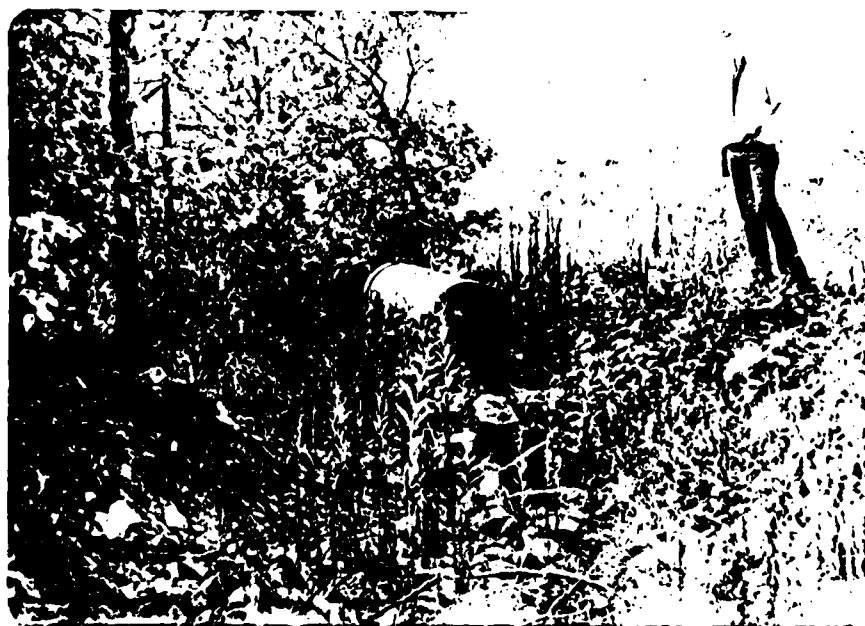
The downstream section of the outlet pipe was in good condition, showing no signs of significant deterioration.

Photo 6 - Discharge end of corrugated metal pipe used for service spillway.

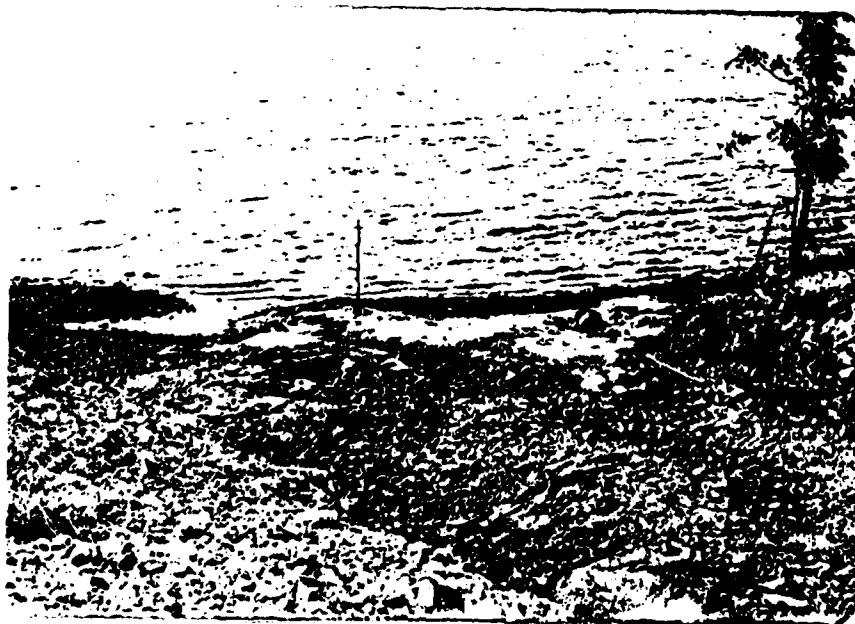
Photo 8 - Approach channel for emergency spillway. Note post for former fence across spillway.

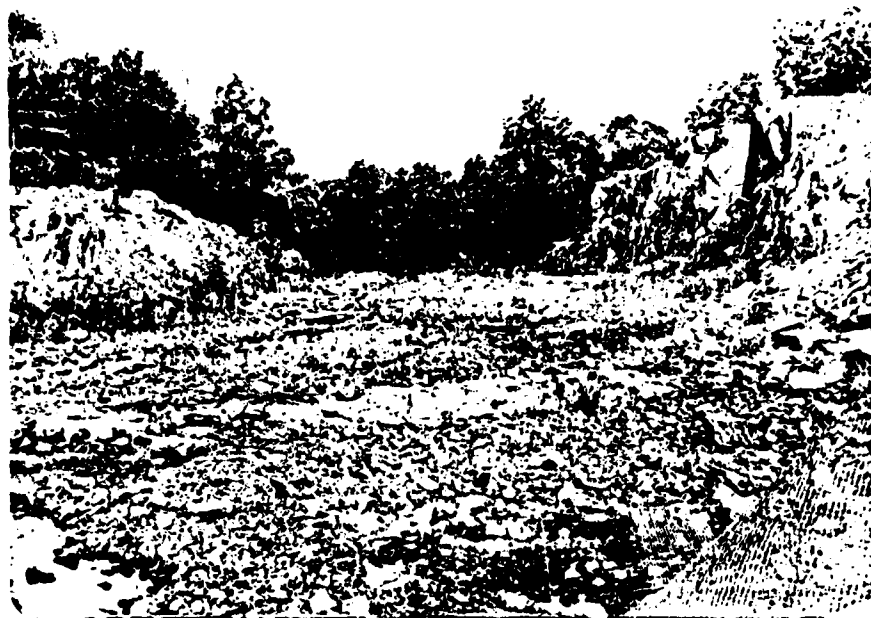
Photo 9 - Picture of emergency spillway channel taken from upstream.

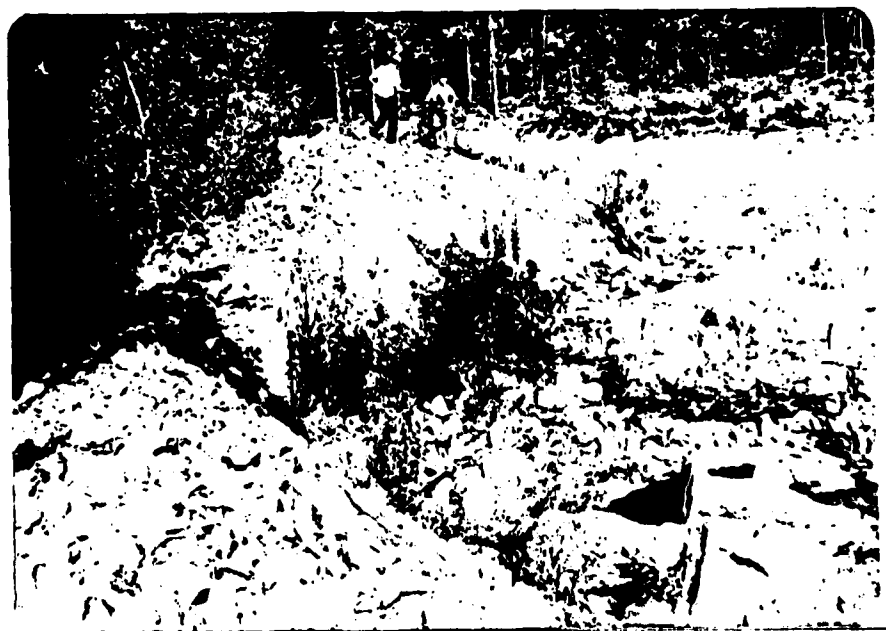
The intake box on the service spillway is tilted approximately 5° from its original position. The emergency spillway discharge channel bed is in rock, and is in good condition, except that the left bank of the discharge channel which is badly eroded and shows signs of instability.

Photo 12 - Close-up of eroded left bank of emergency spillway discharge channel.
